Flex System x220 Compute Node Installation and Service Guide

Machine Types: 7906, 2585

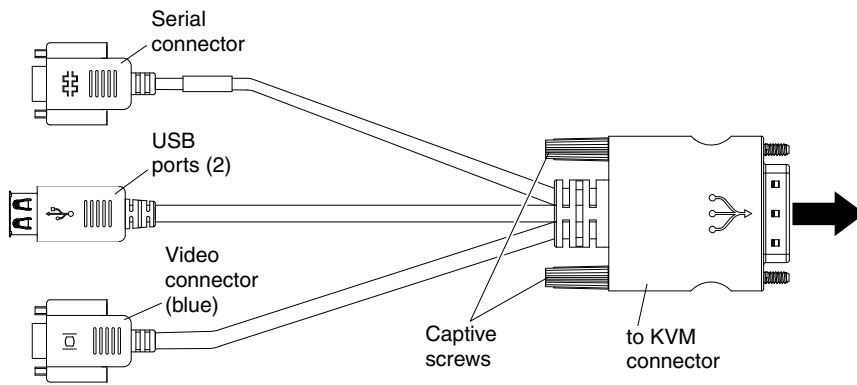
Use the console breakout cable to connect external I/O devices to the compute node. The console breakout cable connects through the KVM connector (see “Compute node controls, connectors, and LEDs” on page 11). The console breakout cable has connectors for a display device (video), two USB connectors for a USB keyboard and mouse, and a serial interface connector.

The following illustration identifies the connectors and components on the console breakout cable.
